THE TEHACHAPI EARTHQUAKE OF JULY 21, 1952

by G. W. Housner*

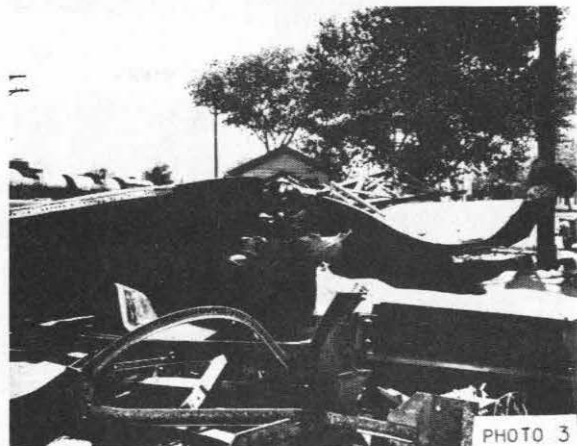
PHOTO 3

WATER TANK IN TEHACHAPI

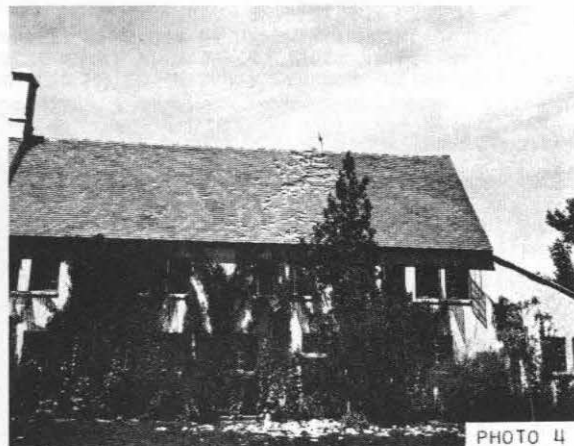
PHOTO 4

The Women's State Prison, located approximately ten miles west of Tehachapi, is composed of a number of two-story, reinforced concrete buildings having steeply pitched tile roofs and wood roof framing. These buildings suffered moderate damage; brick chimneys toppled, gable walls cracked, window mullions and spandrel beams cracked. The buildings were designed and constructed just prior to the earthquake of March 10, 1933 and had not been specifically designed to resist earthquakes but they were relatively sturdy buildings for that type of construction.

REINFORCED CONCRETE BUILDING AT WOMEN'S PRISON. BRICK CHIMNEY DOWN. ONE-HALF OF CHIMNEY CAME DOWN ON THIS SIDE (NOTE 2 REINFORCING BARS). OTHER HALF WENT DOWN ON OTHER SIDE. (OTHER TWO BARS BENT OTHER WAY).

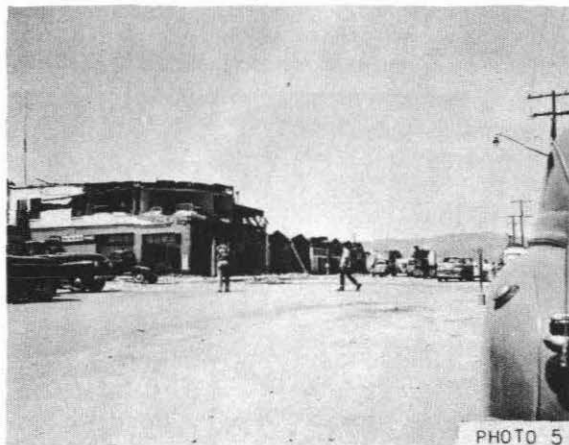
PHOTO 5

The intensity of the ground motion at Tehachapi is estimated to have been approximately the same or perhaps somewhat less than that at Long Beach, March 10, 1933. Practically all of the commercial buildings in the town were small, old and of shoddy construction and these were very severely damaged. It was reported that eleven persons were killed in Tehachapi and surrounding area by collapsing buildings. The loss of life would undoubtedly have been much greater had the shock occurred later in the day when the commercial buildings would have been occupied. The Tehachapi Lodge building, erected in 1930, a small, two-story, reinforced concrete, box-type structure, withstood the shock with only interior plaster cracking and spalling. A large steel water tank in the town, which had only light bracing not designed for earthquake forces, collapsed completely. The residences in the town, which for the most part were one-story, wood-framed structures, suffered only minor damage.

MAIN STREET IN TEHACHAPI

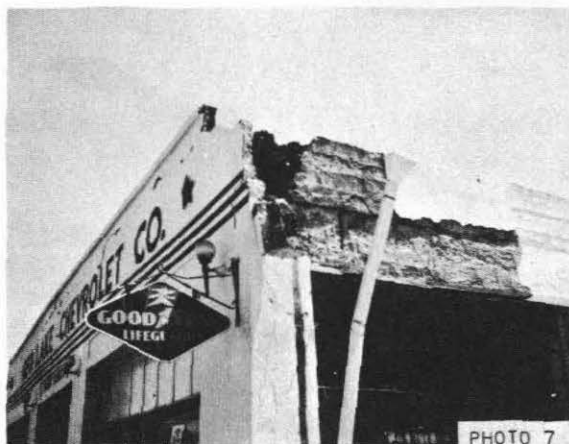
PHOTO 7

BUILDING IN TEHACHAPI

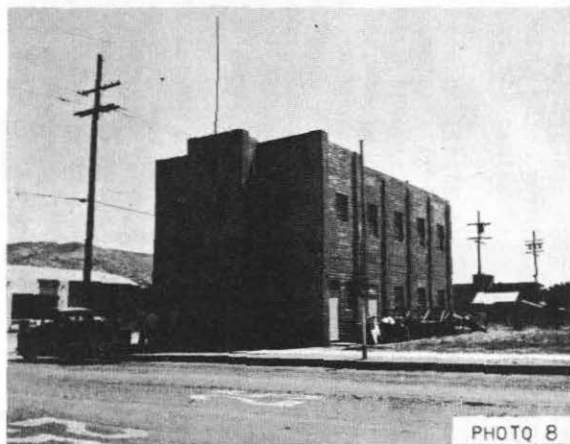
PHOTO 8

REINFORCED CONCRETE LODGE BUILDING IN TEHACHAPI, SUFFERED ONLY INTERIOR PLASTER DAMAGE, ERECTED IN 1930.

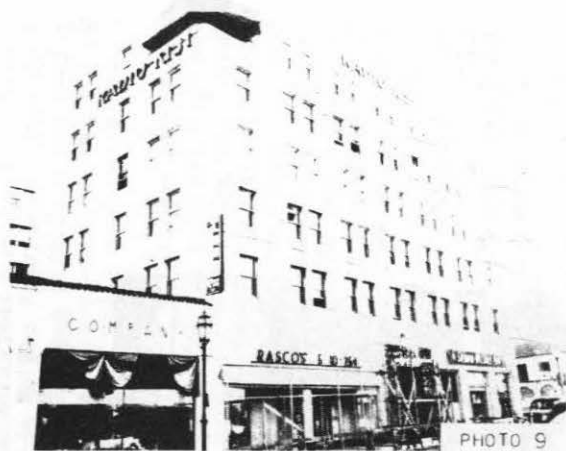
PHOTO 9

A number of buildings in the city of Santa Barbara were damaged by the earthquake. The damage was chiefly cracking of walls and in all cases the buildings were old and had not been designed and constructed to resist earthquakes. A six-story building which houses the Santa Barbara radio station suffered serious cracking in the first and third-story walls and the five-story Carillo Hotel building had serious cracking in the first-story walls. There was no collapse of building such as had occurred in Tehachapi and the intensity of the ground motion was much less in Santa Barbara than in Tehachapi.

RADIO STATION BUILDING
IN SANTA BARBARA

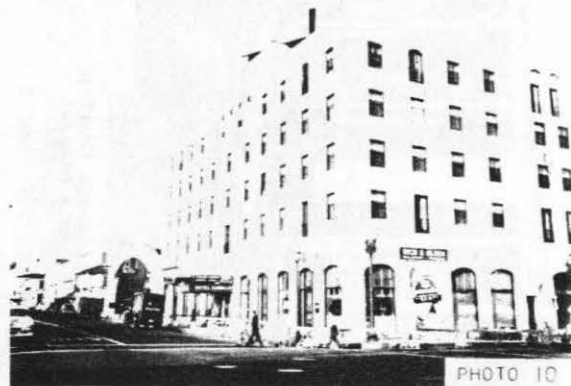
PHOTO 10

CARRILLO HOTEL IN
SANTA BARBARA

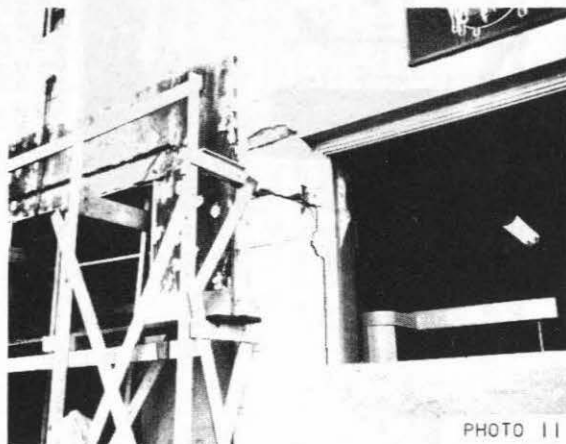
PHOTO 11

RADIO STATION BUILDING IN SANTA BARBARA. REIN-
FORCED CONCRETE FRAME. WAS ALSO DAMAGED IN
SANTA BARBARA EARTHQUAKE OF 1925.

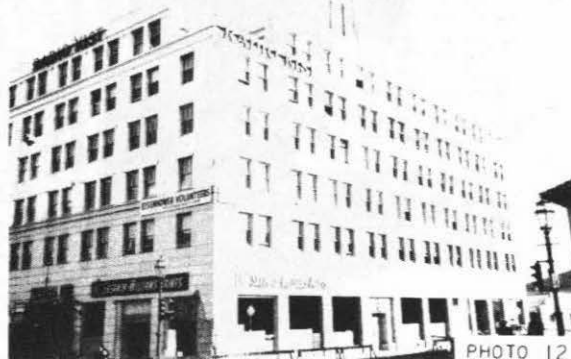
PHOTO 12

RADIO STATION BUILDING
IN SANTA BARBARA

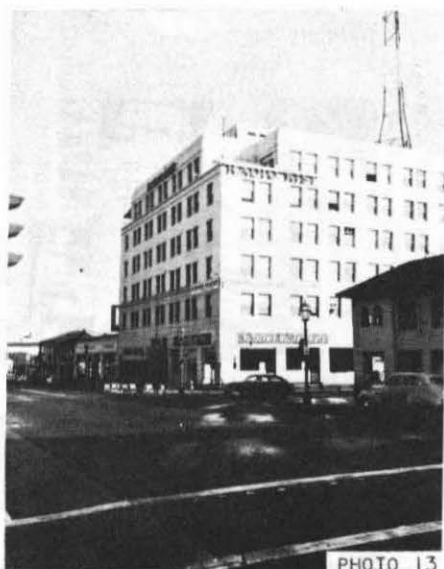
PHOTO 13

RADIO STATION BUILDING
IN SANTA BARBARA

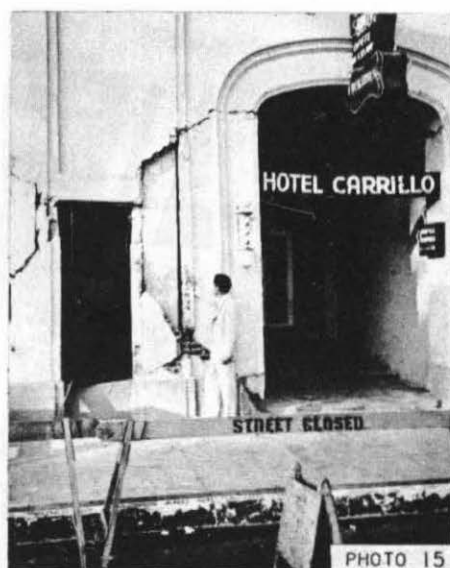
PHOTO 15

CARRILLO HOTEL IN SANTA BARBARA
SHOWING REINFORCED CONCRETE
COLUMN AND CRACKING OF BRICK
FILLER WALLS. SIGN BUCKLED. NOTE
AMOUNT OF MOVEMENT FROM CRACK.
